# Learning from Texas Wildfires: Bastrop State Park and Beyond

Funded by a grant for the  
National Park Service's Center  
for Preservation Technology  
and Training

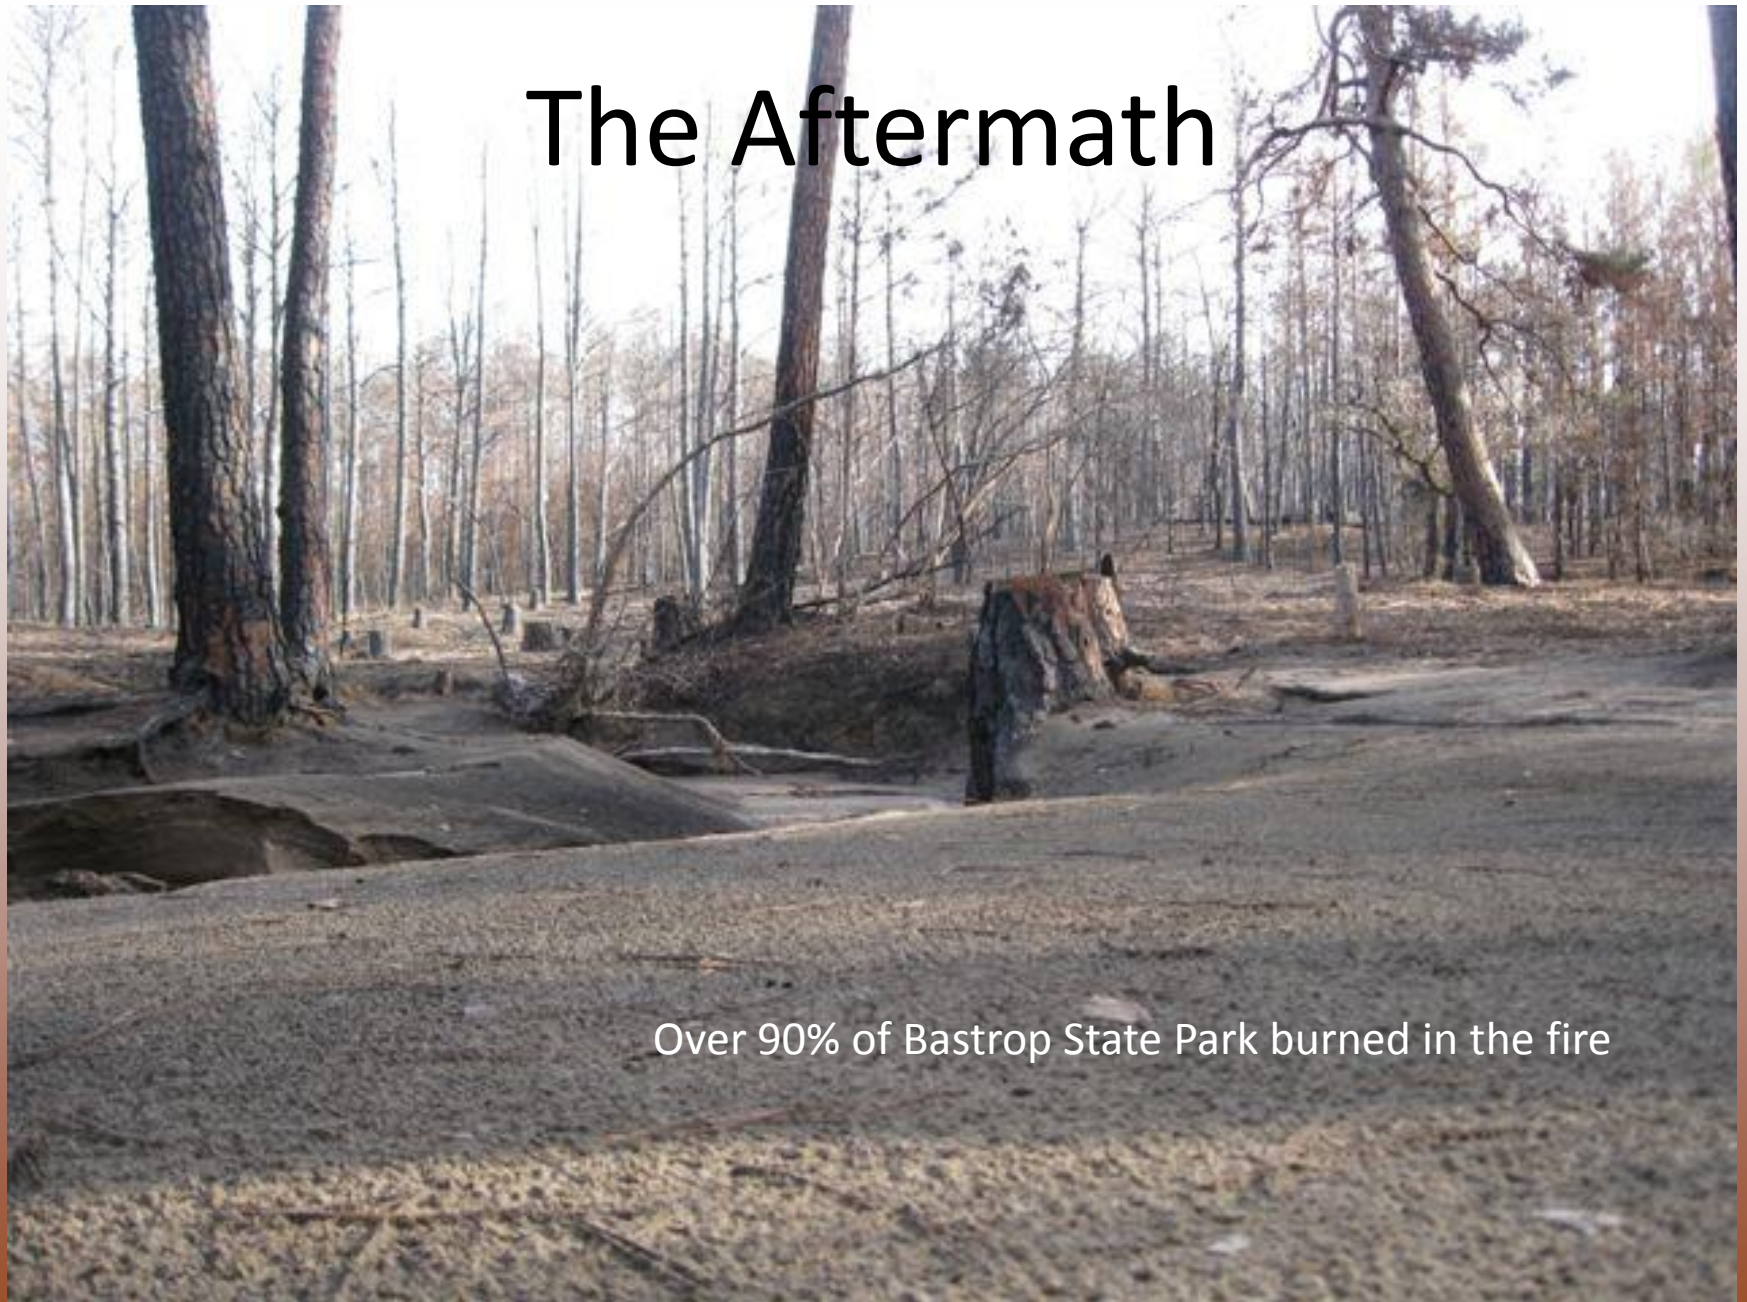
Over 90% of Bastrop State Park burned in the fire

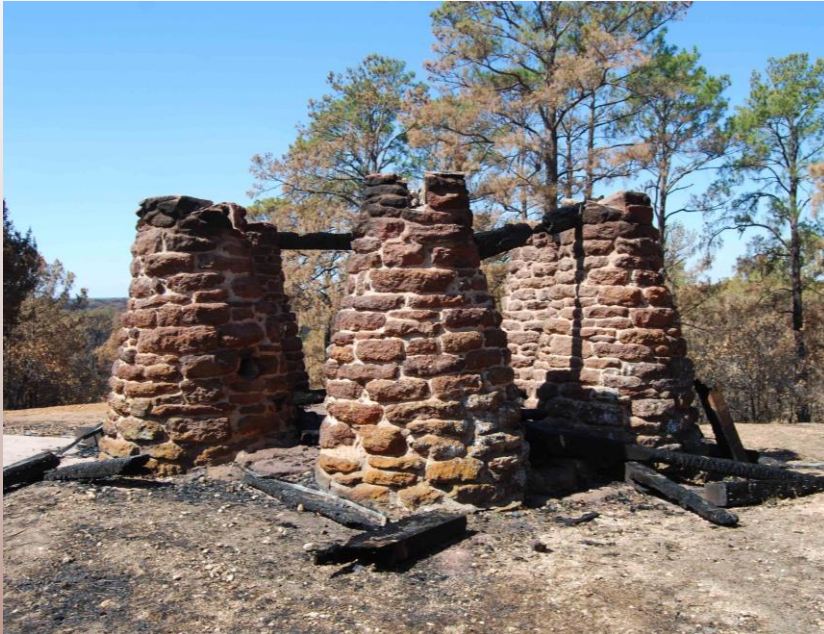
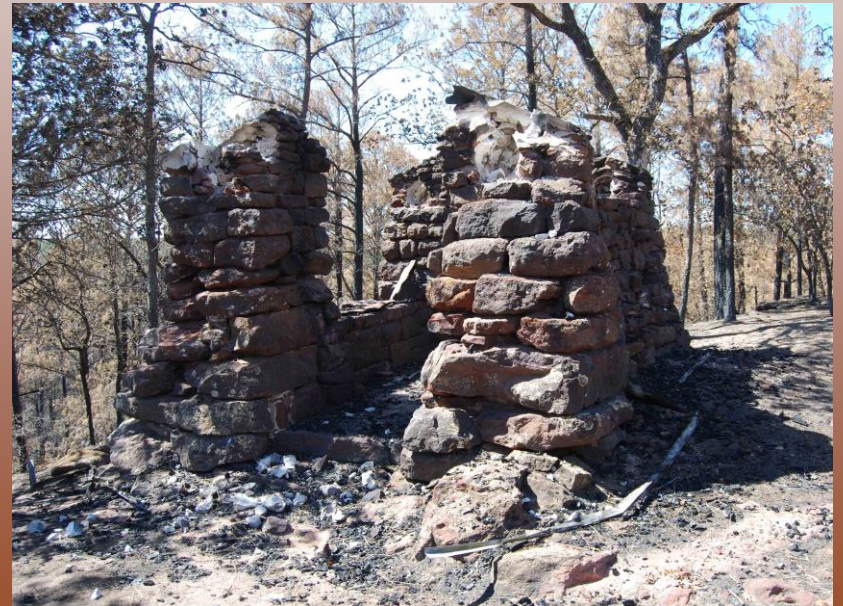
Because of their remote locations, the terrain surrounding them, the path of the fire and the priority of the more significant historic structures, both overlooks burned.

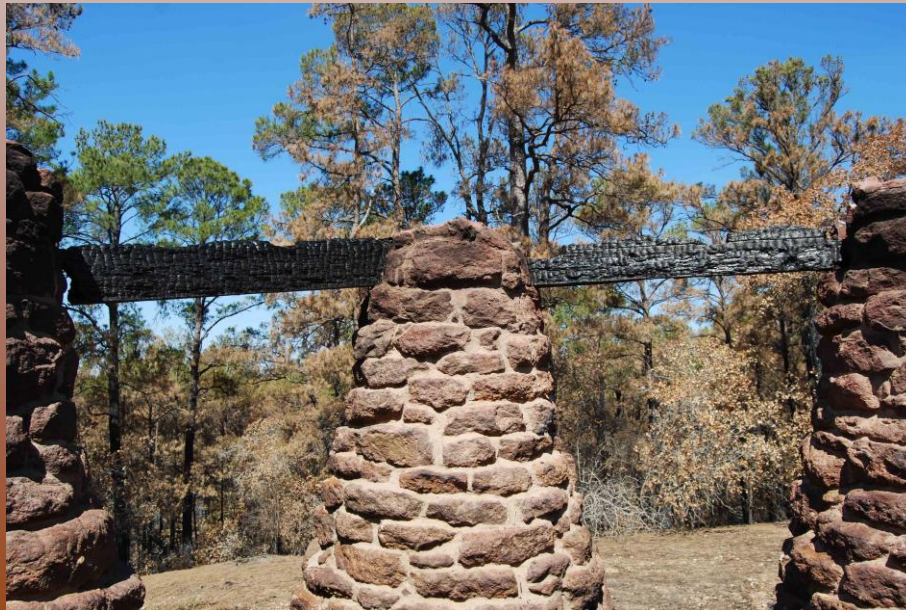
- Burning begins at 248° - 302°
- Bastrop fire produced air temperatures of almost 1,400° before the fire arrived
- Wood of overlook roofs were burned completely

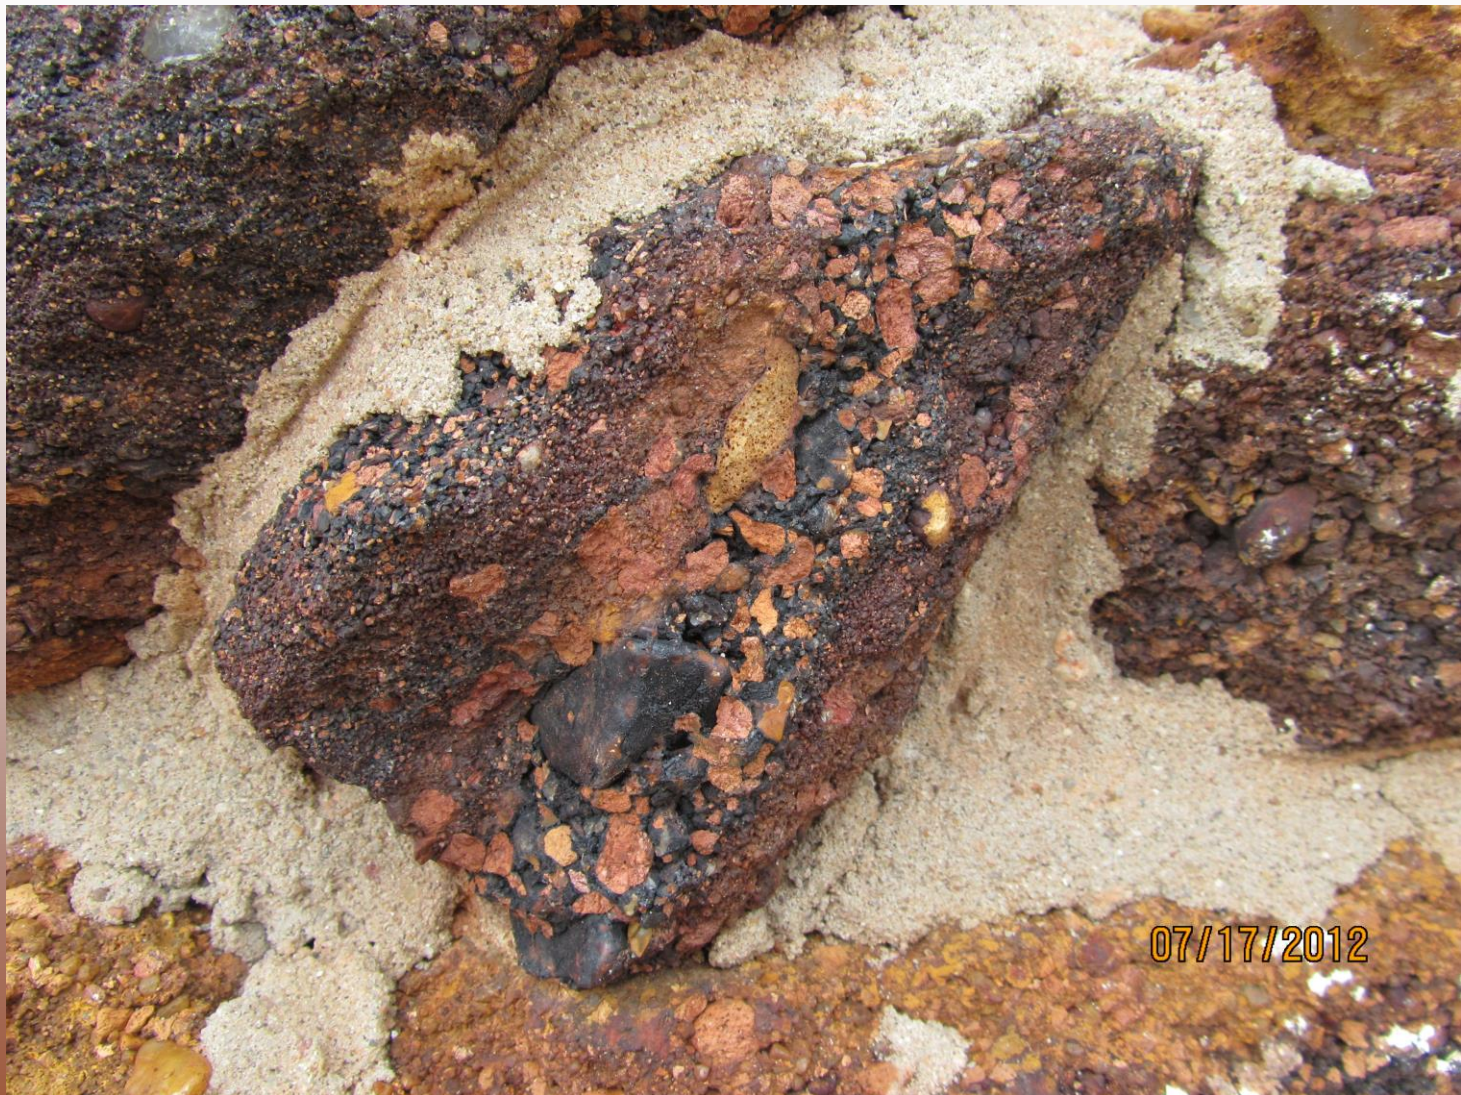
- Mortar can be weakened by a fire, which can dehydrate the cement.
- Mortars typically lose strength at 572 - 752°
- Damage can range from shallow powdering (top half inch) to total disintegration.
- At BSP, the mortar was in generally good condition: superficial soiling but little visible damage
- After wildfires, mortar on structures should be regularly inspected to monitor possible weakness

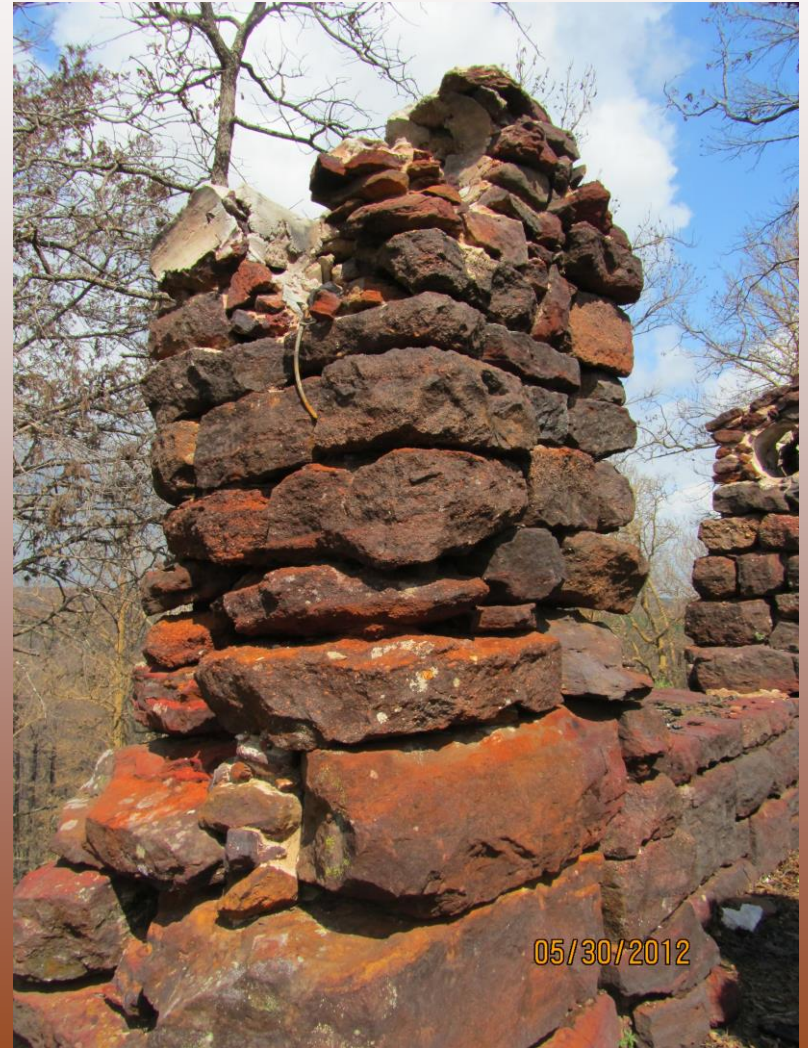
- Because of sandstone's porosity, it withstands fire damage better than stone like Granite.
- Sandstone can begin to deteriorate at  $842^{\circ}$
- Difficult to assess full damage because of issue of "shock versus fatigue" effects.

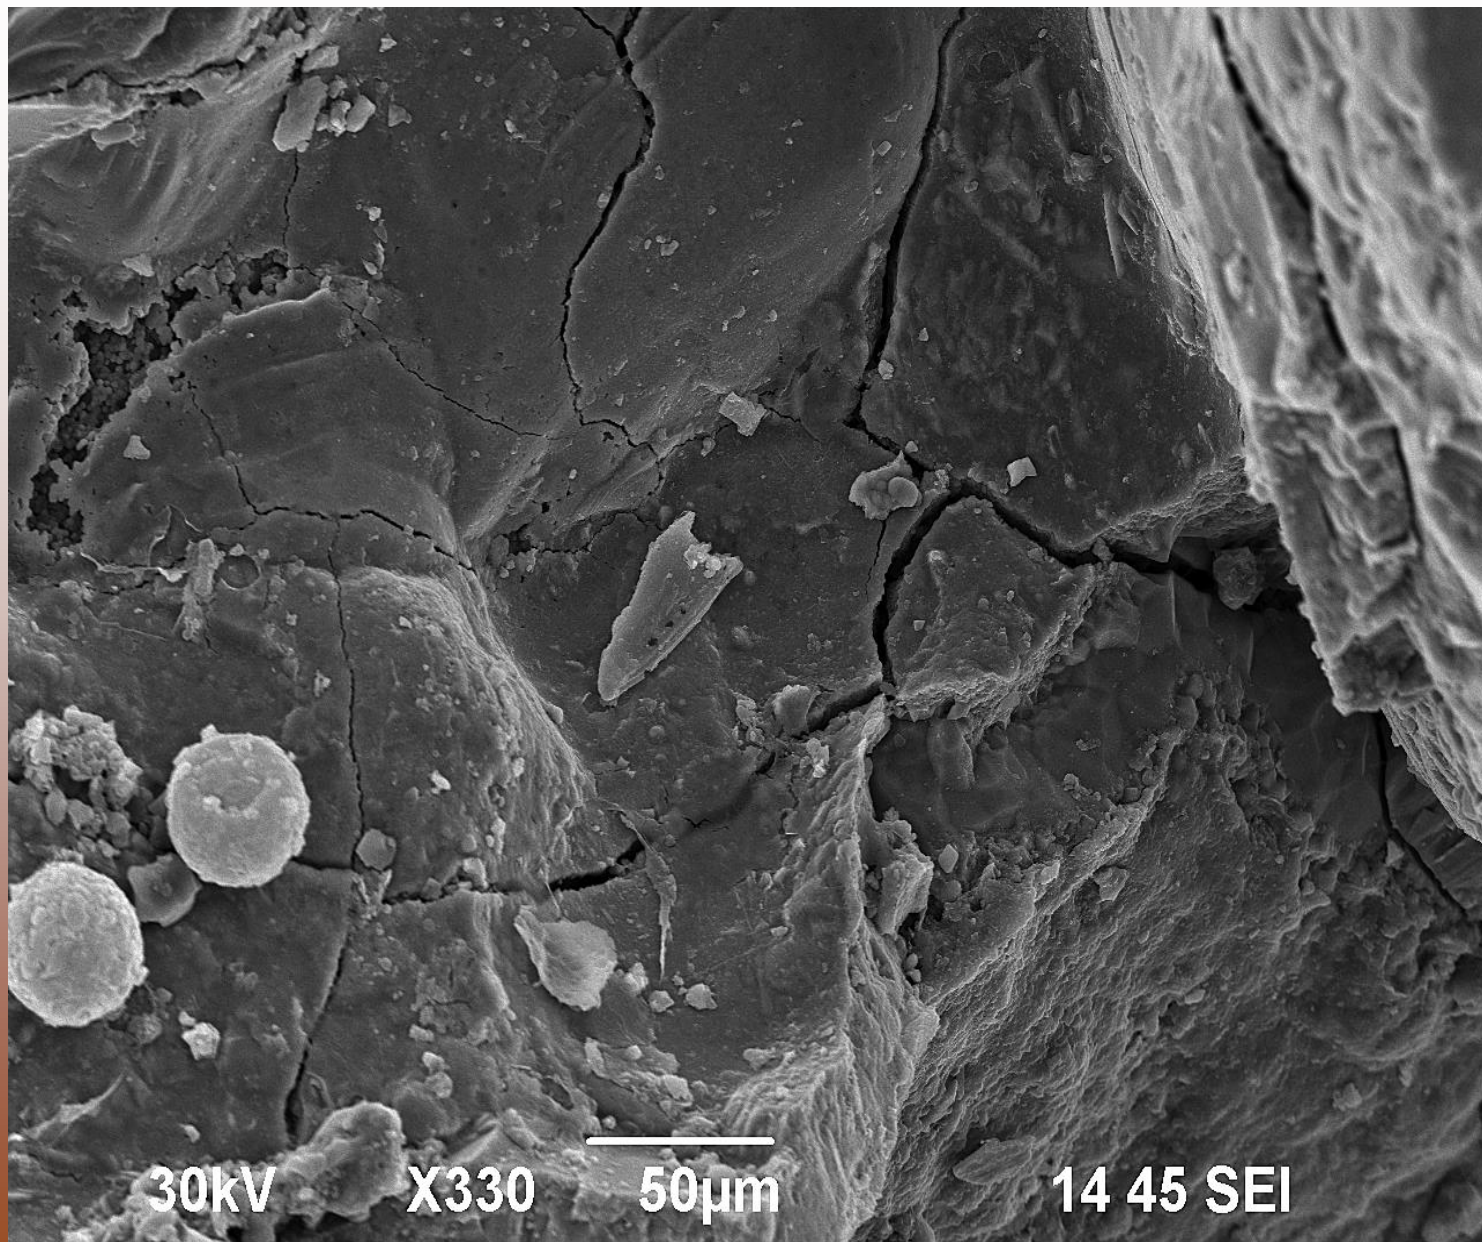
- Burned and unburned samples taken
- Assessed under a scanning electron microscope
- Samples showed no definitive fire decay
- Also tested for water absorption, but results were inconclusive
- Regular inspections should be made with special attention to cracking or other damage that may develop in the long term

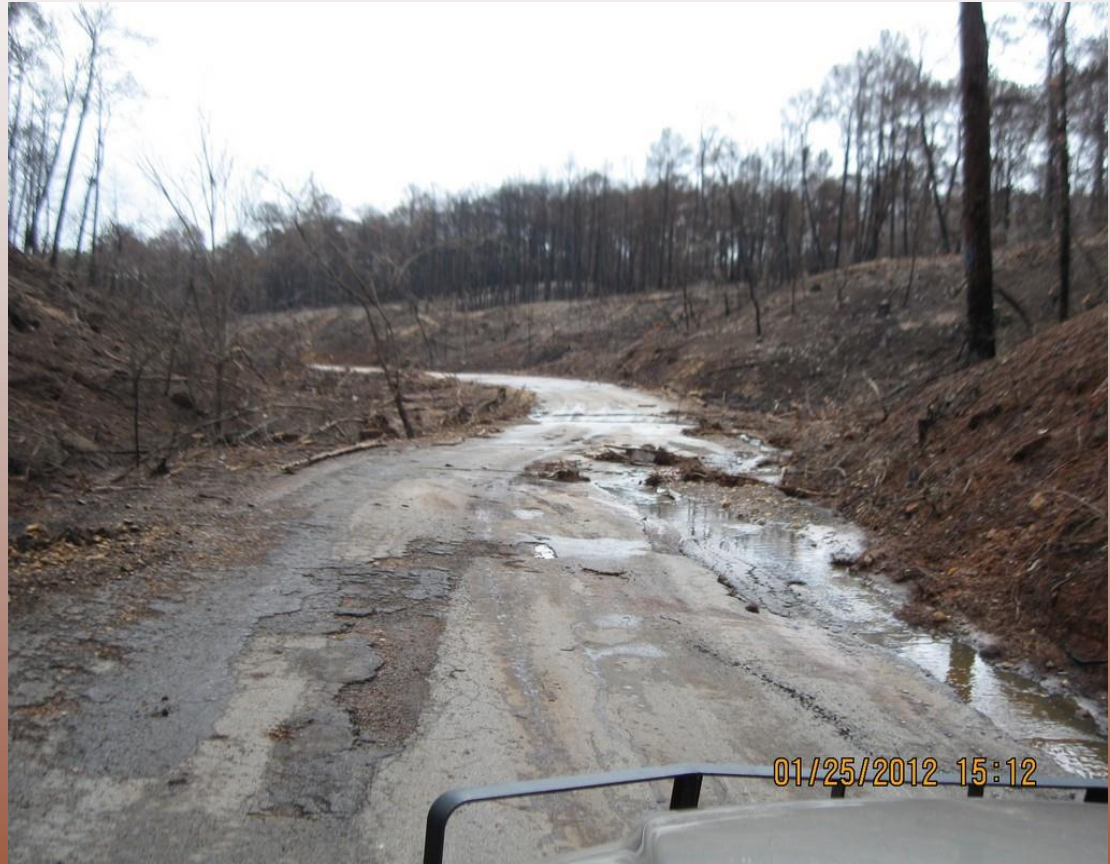
- BSP suffered severe erosion problems as a result of the extreme loss of vegetation
- Sloping terrain added to the problem
- BSP was vulnerable to severe erosion in approximately 30% of the park
- A January 2012 storm created an “emergency situation” and required immediate erosion control
